**THE WAYNE FRAMEWORK 2019** APPENDIX

# SUMMARY OF BUILDING ASSESSMENT

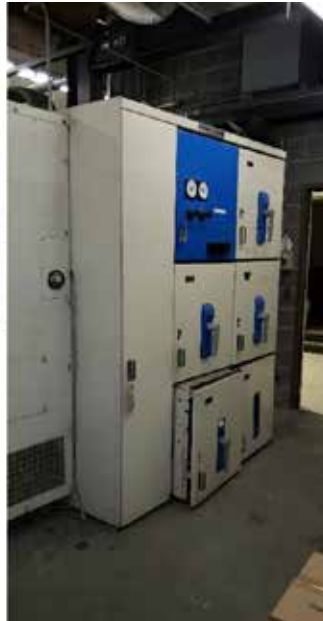
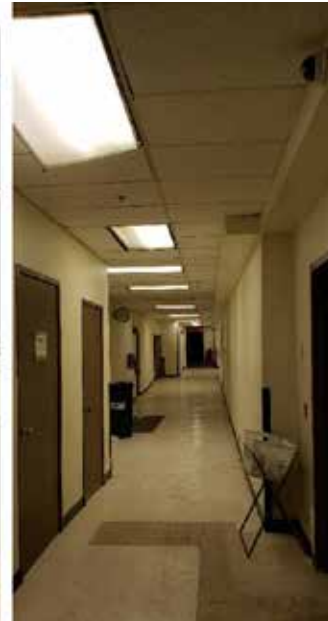
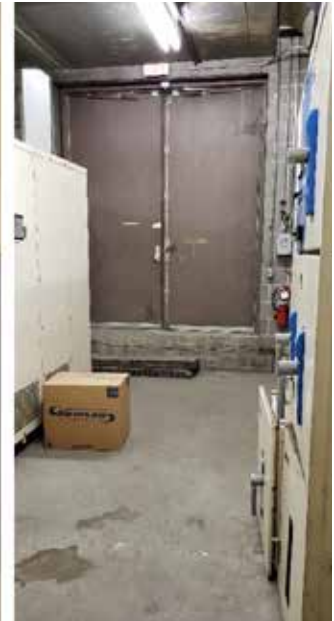
- Many leaks from roof.
- Damaged ceiling tiles release asbestos when removed from the ceiling.
- Air handling unit coils corroded, blocked, and have burst coils.
- Building engineer keeps the doors opened to prevent coils piping from freezing.
- Two Air handling units serving Annex are not working due to burst coils.
- Cooling towers need replacement, one of the chillers has not been working for years.
- Leaks from steam and condensate piping.
- Need to evaluate the working conditions of the fire pumps, there are some corroded parts.

- This building was upgraded when Wayne State University purchased it back in 1995.
- Boilers installed in 2007.
- Some pneumatic controls and some Siemens digital direct controls (DDC) as well, many controls not working.
- Refrigerant monitoring not working.
- Many leaks in domestic cold water [DCW] piping. One of two DCW main lines blocked, no water for 2 years now for some parts of the building.
- Wall and floor mounted flush valves are ADA compliant. Many blocked water closets.
- No over flow roof drain. New roofing will provide better seal and insulation that will save energy. Code require to installing new overflow roof drain system when replacing roof.
- Animal lab exhaust not working.

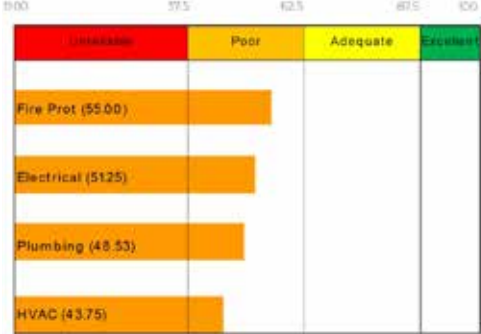
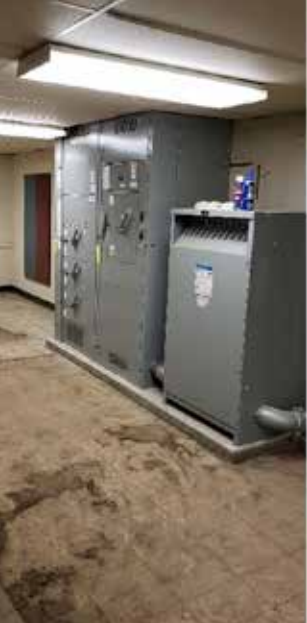
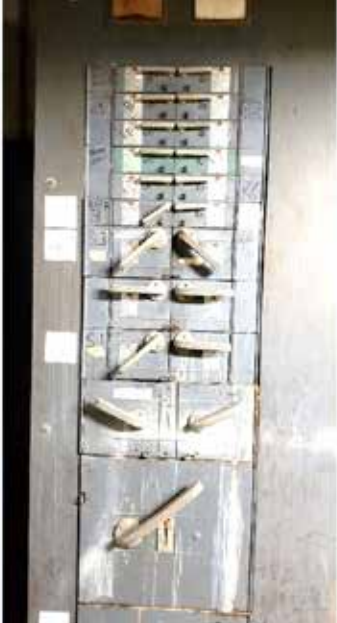
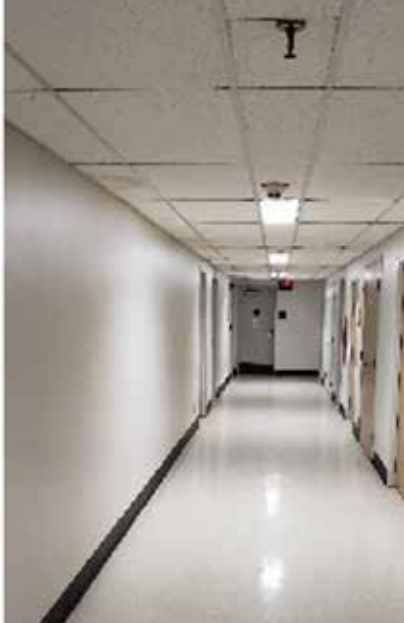
# 5425 WOODWARD

**Key takeaway:** The systems at 5425 Woodward cannot support office activity without significant investment.

- Current HVAC system needs to be evaluated for replacement with simplified and more efficient system.
- Need to replace one of the two chillers.
- Need to replace domestic hot water heat exchanger.
- Some steam, condensate, heating hot water, domestic hot water, chilled water piping and valves need to be replaced.
- Unable to gain entry into switchgear room – unable to determine incoming voltage
- Secondary power distribution panels are in poor condition with little capacity for future loads
- Fire alarm system has audio signaling only, with a bell system. There are no visual signaling devices per ADA for hearing impaired occupants.
- Entire building is backed up by a generator

- Boilers were installed in 2007 and have many years left in their service life time.
- Two air cooled chillers. One of them needs to be replaced, compressor is not working.

- Air Handling Units (AHUs) in the basement installed in 2005, one of them provides 100% outside air.
- The steam heat exchanger (HX) for domestic hot water (DHW) is broken and needs to be replaced.

- Exit signage are not spaced to meet current egress codes
- Older lighting fixtures, some with burned out/missing lamps and discolored lenses
- There are no means of automatic lighting control

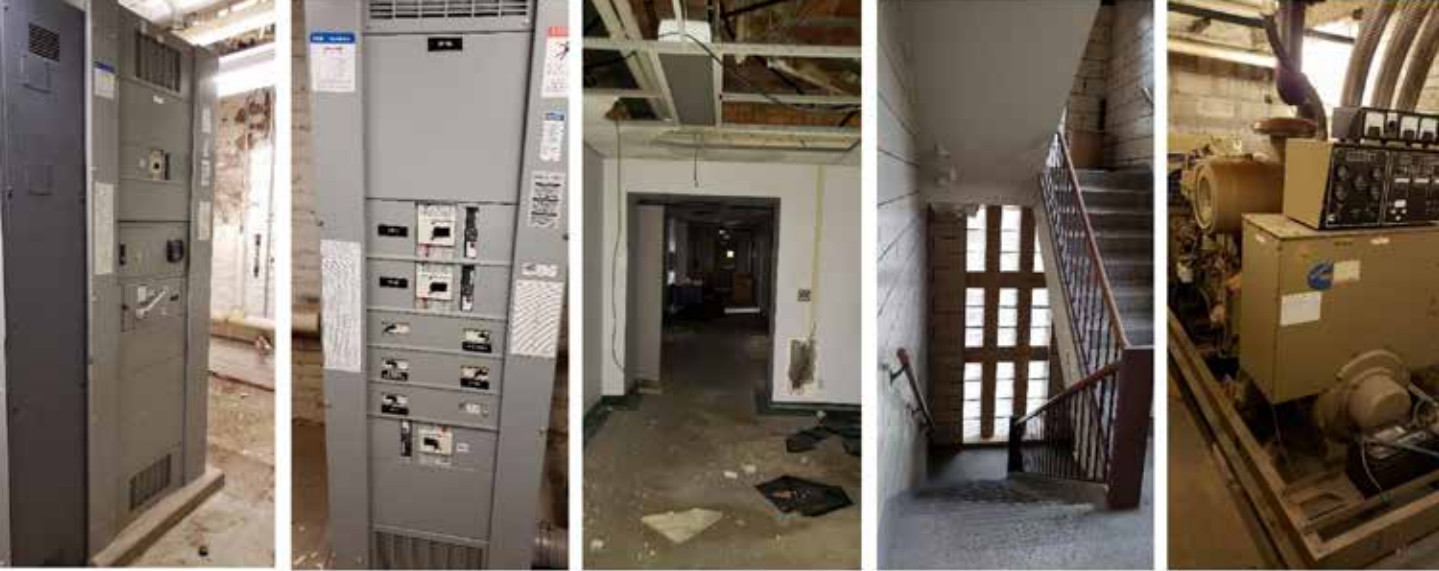
- Need to replace heating system related piping and radiators.
- Add cooling and ventilation system.
- Possible asbestos.
- Entire electrical infrastructure should be upgraded.

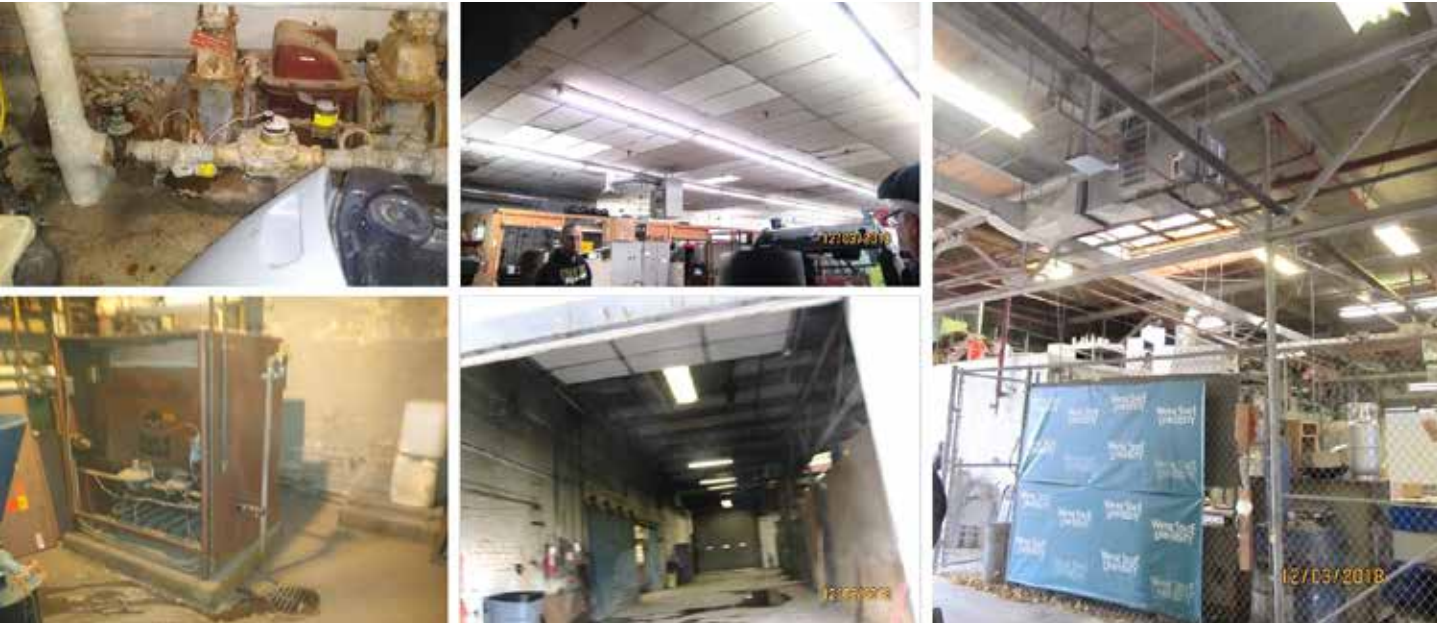
- Old rooftop HVAC units, unit heaters, and ductwork.
- Pneumatic controls need to be replaced.
- Old corroded boiler with some of its parts removed.
- Very old main city water line serving protection line and domestic water line. Old back flow preventer, not per code. Corroded piping.
- Most of the fire protection system is old, but some has been added in recent years.

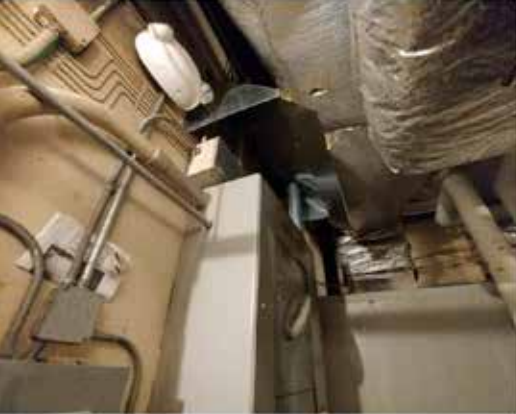
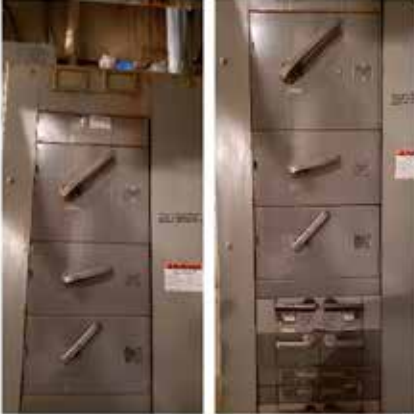
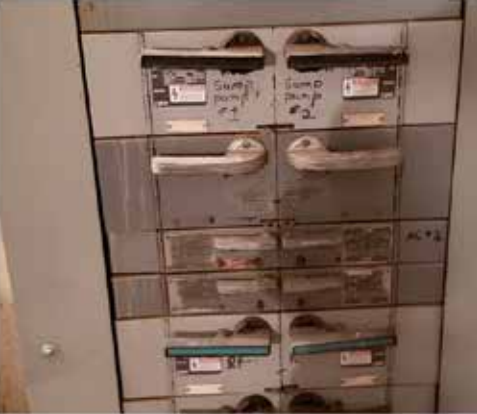
- Heating hot water, chilled water, domestic hot water, and domestic cold water comes from Prentis Building.
- Reflecting pool around building leaks into basement and mechanical rooms, pours in when it rains.
- Reflecting pool needs to be sealed and has not been filled in 20 years. If pool is filled, new mechanical equipment for pool is required.
- Building air intakes are obstructed, louvers are poured in concrete
- Controls are pneumatic and need to be replaced.
- The building heating hot water piping is being replaced because of scale build up restricting flow.
- No fire protection system.
- Major electrical distribution system upgrade is required.
- The auditorium electrical is fed from Prentis Hall with a switchboard that has had constant water dripping on it.

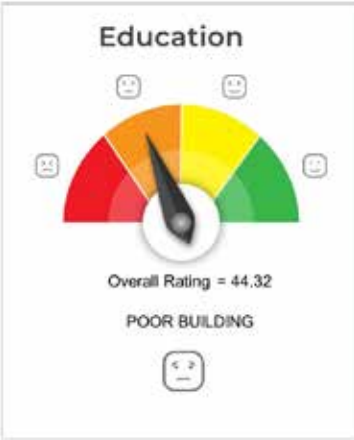
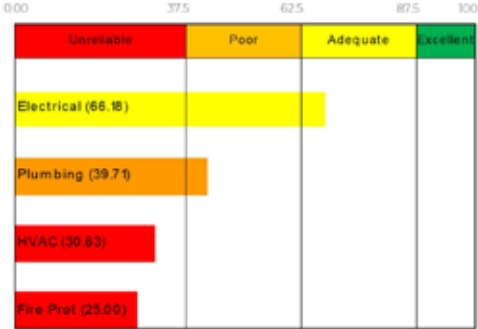
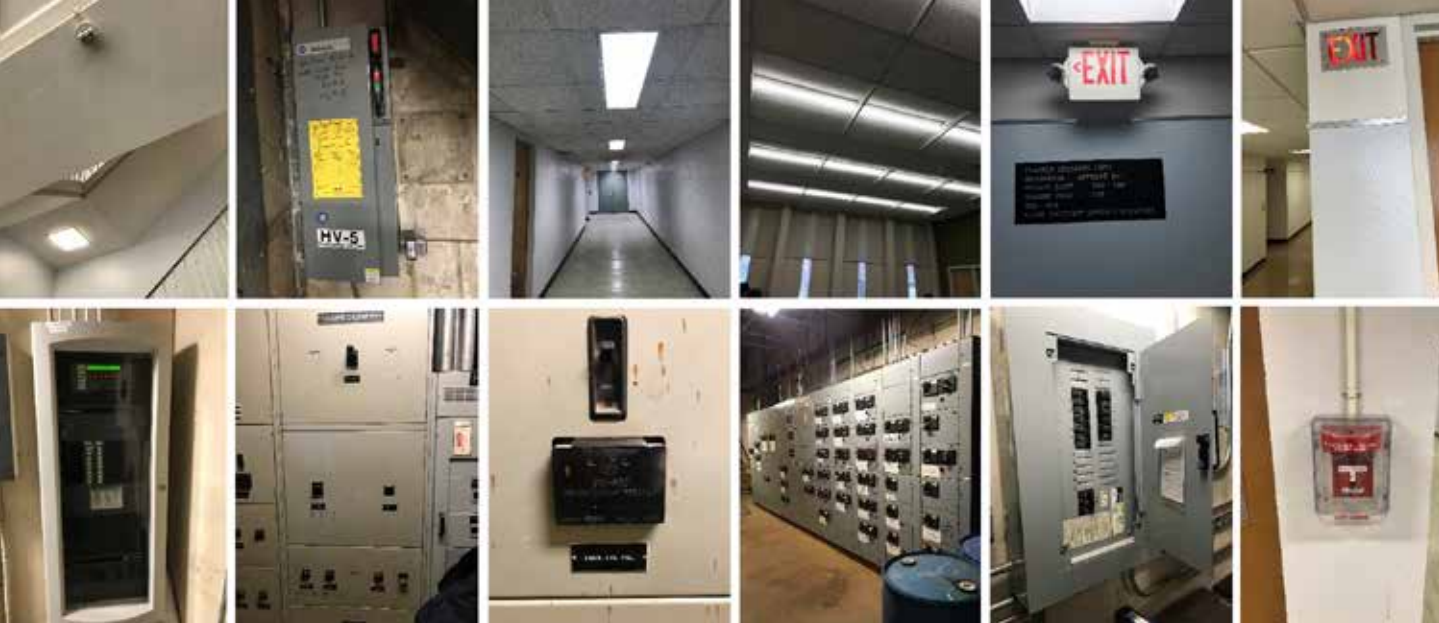
- Old inefficient double deck HVAC system.
- Plumbing systems are old. Hard to find replacement parts for the waste pumps.
- Fire protection is provided only for a couple rooms in the basement. Need to evaluate adding a new fire protection sprinkler system. If building is grandfathered, there might be an option to waive the need for new sprinkler system.
- Low pressure on domestic cold water on upper floors.
- Many roof leaks
- Main incoming service to this building needs an upgrade to a more reliable DTE provided 13.2kV service.
- No automatic means of lighting control in the building rooms and office areas, which does not meet current energy codes.

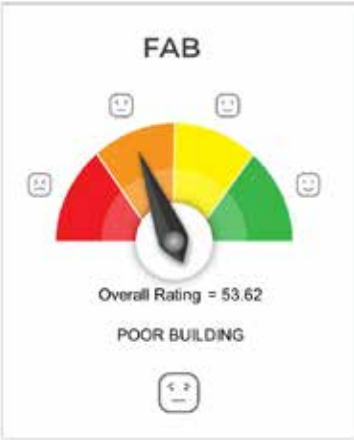
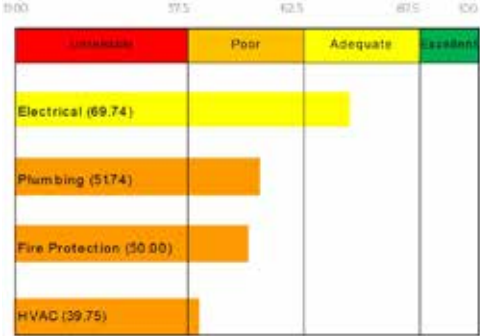
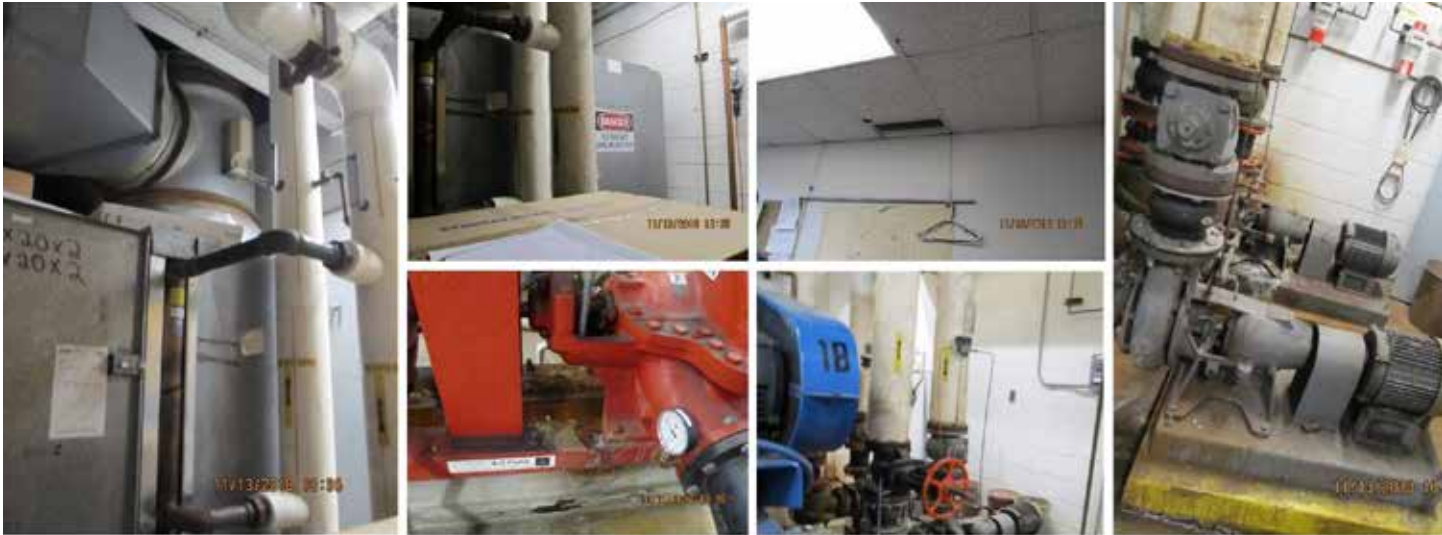
- Outdated DDC controls on rooftop units
- Many roof leaks
- Incoming power is 13.2KV, with a 480V distribution system.

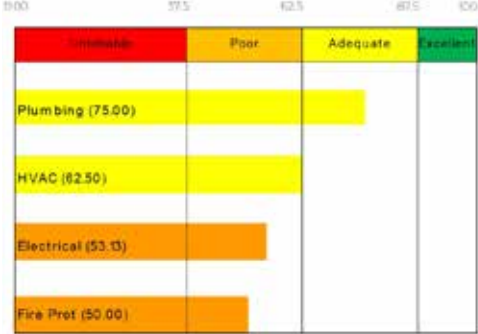
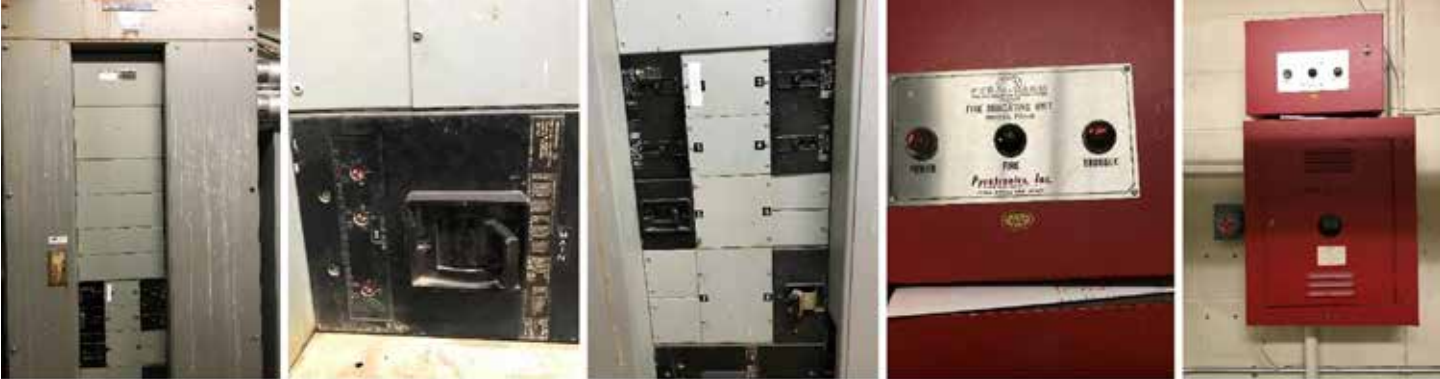
- Fire pump is old and needs to be replaced.
- Perimeter radiators need replacing.
- Steam piping needs to be replaced
- The incoming power is 13.2KV, with 480V distribution system.
- Electrical system requires upgrades.

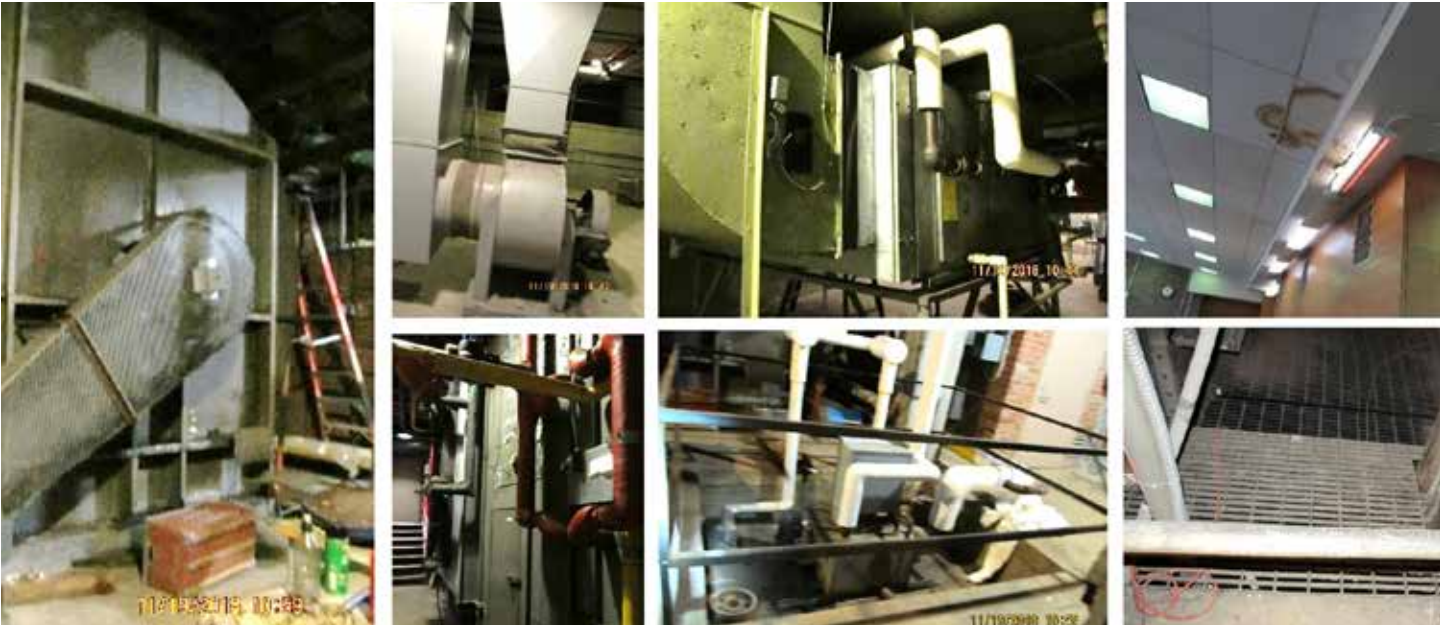
- Outdated pneumatic controls need to be replaced.
- Some equipment controlled manually.
- Induction Air Handling Units provide heating & cooling for perimeter rooms, which makes it difficult to control room temperatures.
- Original motors may fail at any time (bearing was replaced recently).
- Many roof leaks.
- Aging incoming power and power distribution, with panelboards with little spare capacity.
- There is no automatic means of lighting control in the building, which does not meet current energy codes.

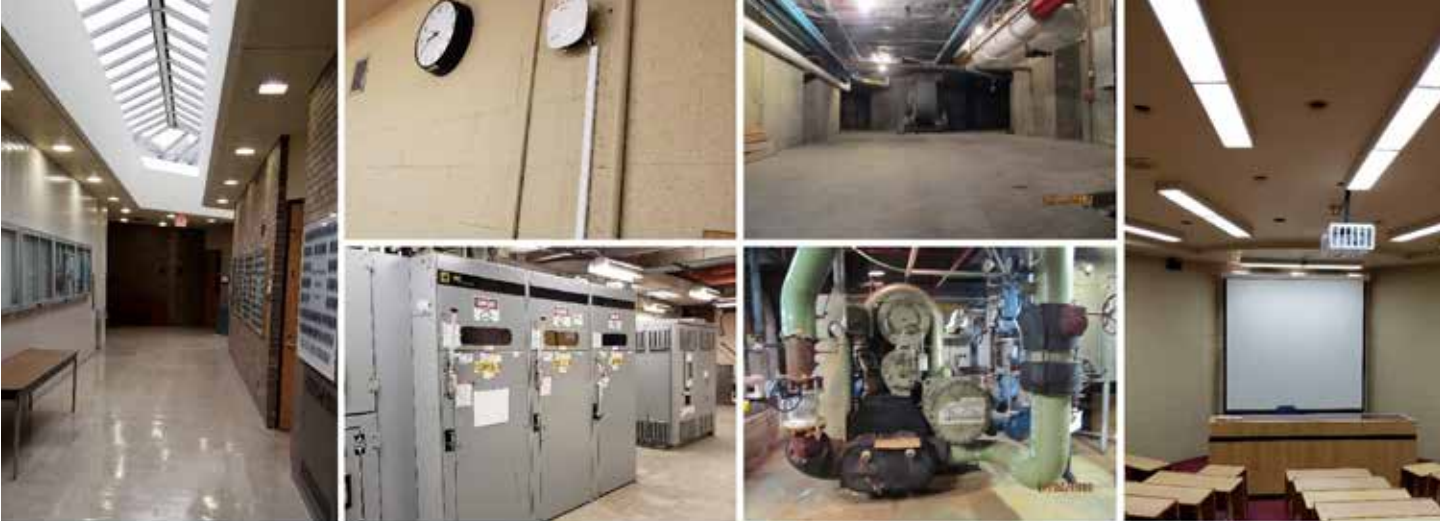
- The incoming power is coming from the Law Library, as well as the fire alarm control panel.
- There is an inadequate amount of panelboards, there were only (2) observed.
- There is no automatic means of lighting control in the building which do not meet current energy codes.
- Leakages in the steam to the heating hot water heat exchanger.
- No fire protection. Only fire alarm provided.
- Evaluate adding new fire protection sprinkler system (possible grandfather option).

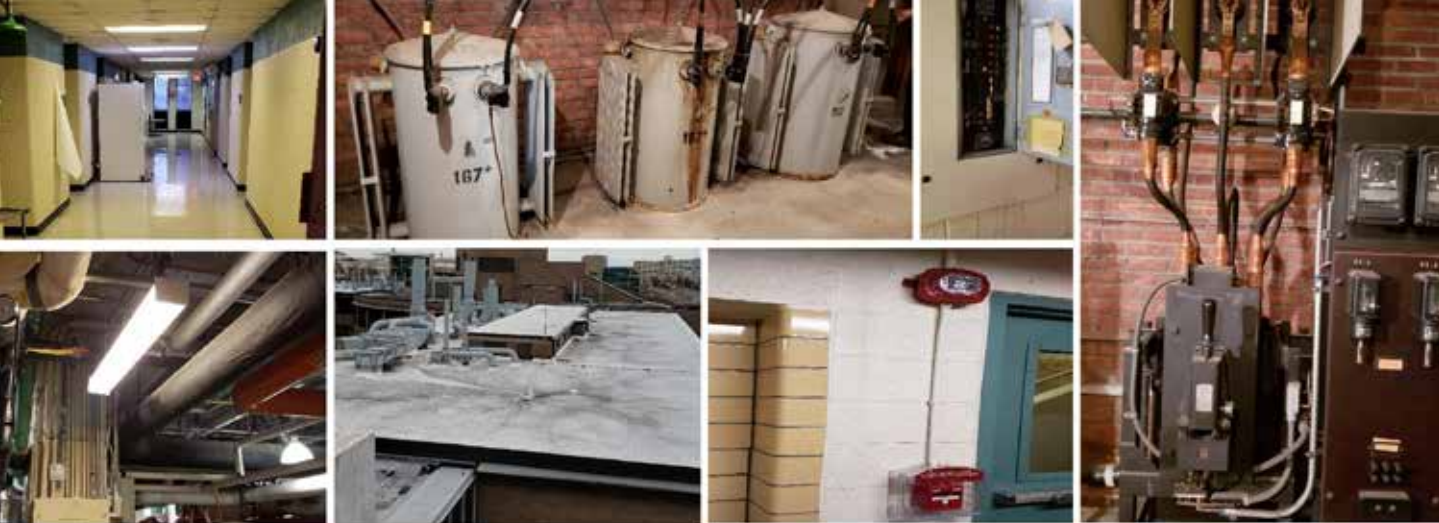
- The entire building requires a major electrical and mechanical overhaul.
- Unable to access the incoming power room, which is operated by Public Lighting. The incoming service is possibly 4800V and should be upgraded to a more reliable DTE provided 13.2KV service.
- There is no working fire alarm system, and is currently using fire watch personnel.
- Domestic hot and cold water piping needs to be replaced.
- Need new hot water source. Natural gas piping has some leaky valves.
- Hydronic piping and steam piping needs replacement.
- Existing chiller and cooling tower abandoned.
- Labs needs new lab air compressor. Lab vacuum not functioning and needs to be replaced. Lab hoods have no controls.
- Fire pump abandoned, no sprinkler system.
- Ductwork needs to be cleaned.
- Cold rooms not functioning.
- Fourth floor cold room roof has leaks.

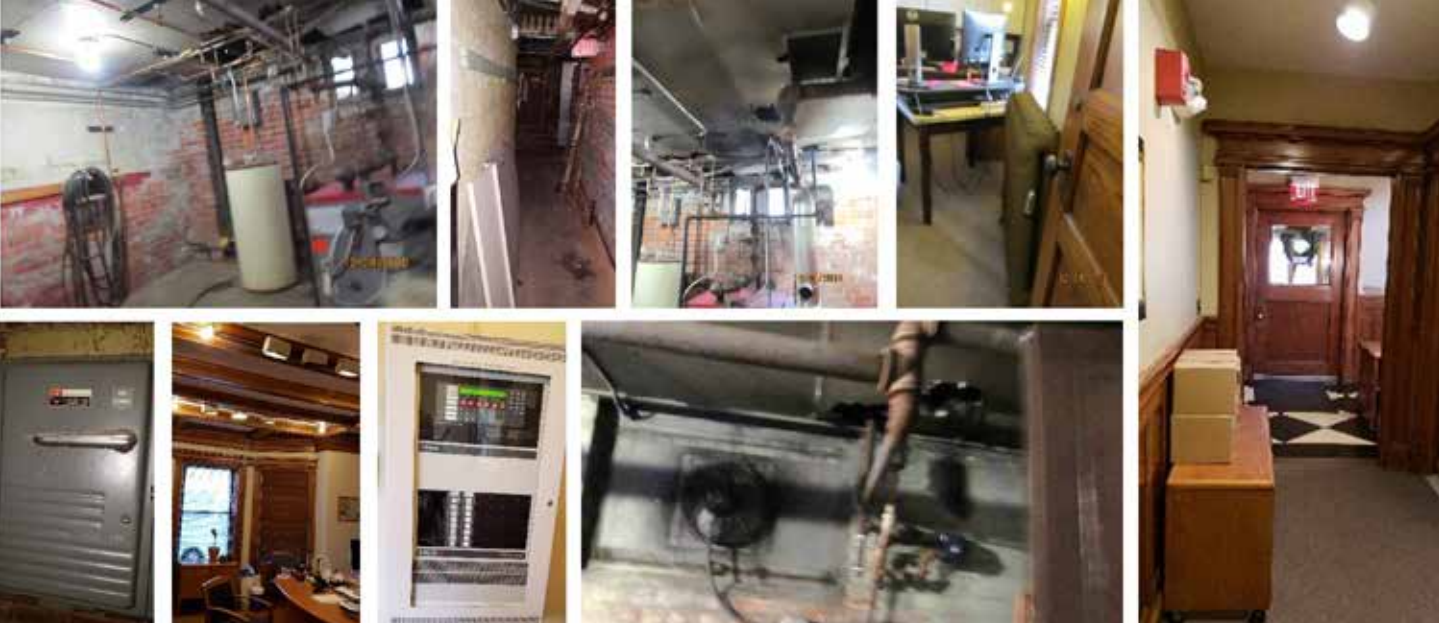
- High water table around building/basement, pump was replaced a couple years ago.
- Gravity storm galvanized piping from 1st and 2nd floors.
- Sewer blocked in the boiler room.
- Low pressure steam boiler in the basement.
- Heating provided via low pressure steam radiators.
- Domestic hot water (DHW) provided by water heater
- Updated and adequate lighting.
- Power distribution was more along the lines of a residential dwelling than a commercial building.

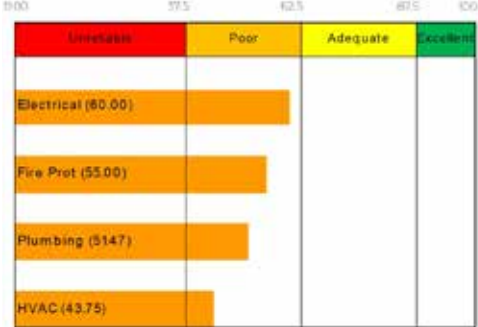
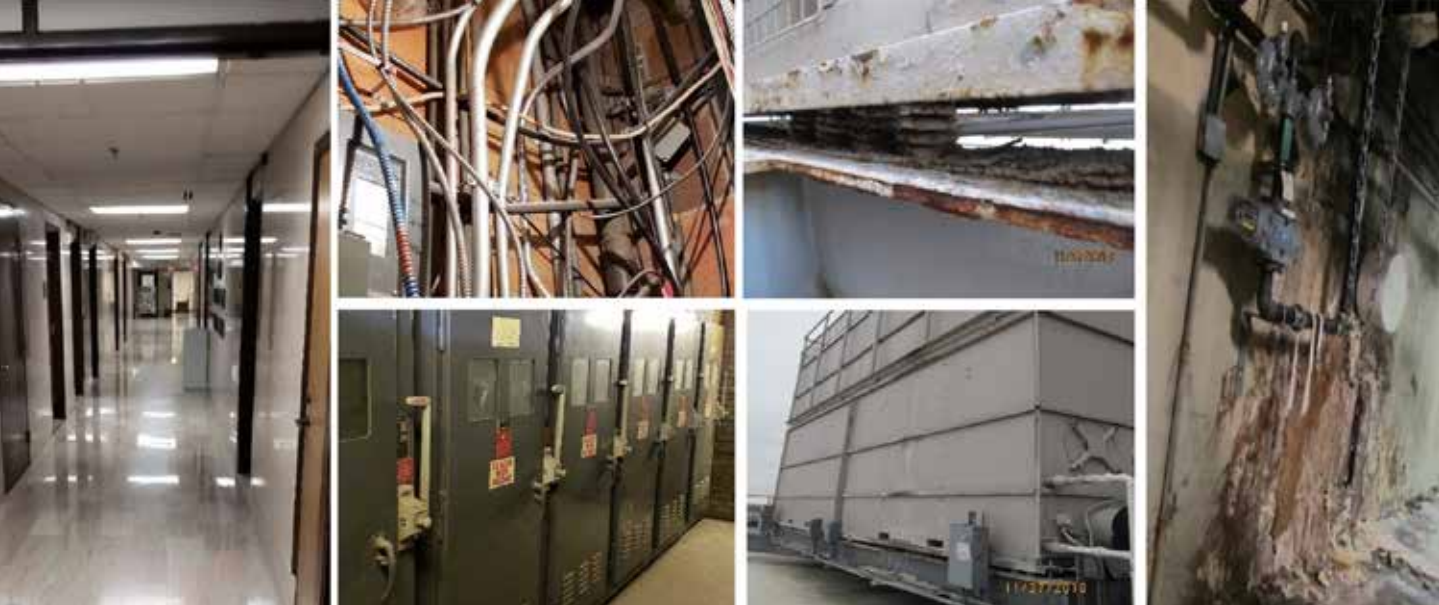
- Aging electrical infrastructure with limited future capacity
- Over 200 heat pump units require continuous maintenance and replacement
- Lack of outside air during summer

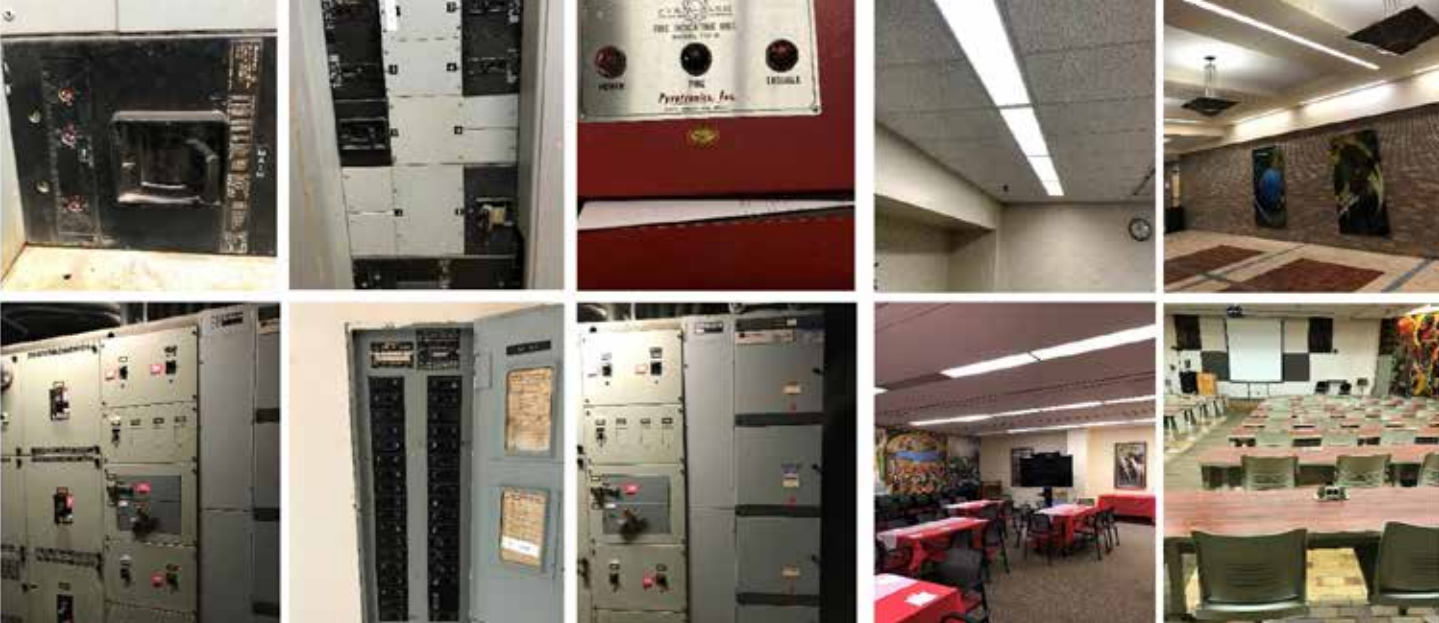
- One of the highest utilization buildings on campus.
- Boilers scheduled for re-tubing, water softener system should be evaluated.
- Operators are running building manually, controls should be replaced.
- The incoming service is 4.8 KV, with a 480V distribution system.
- Some of the panelboards are old and rusty.
- Electrical distribution system needs to be upgraded.
- Emergency lighting does not meet current life safety codes.

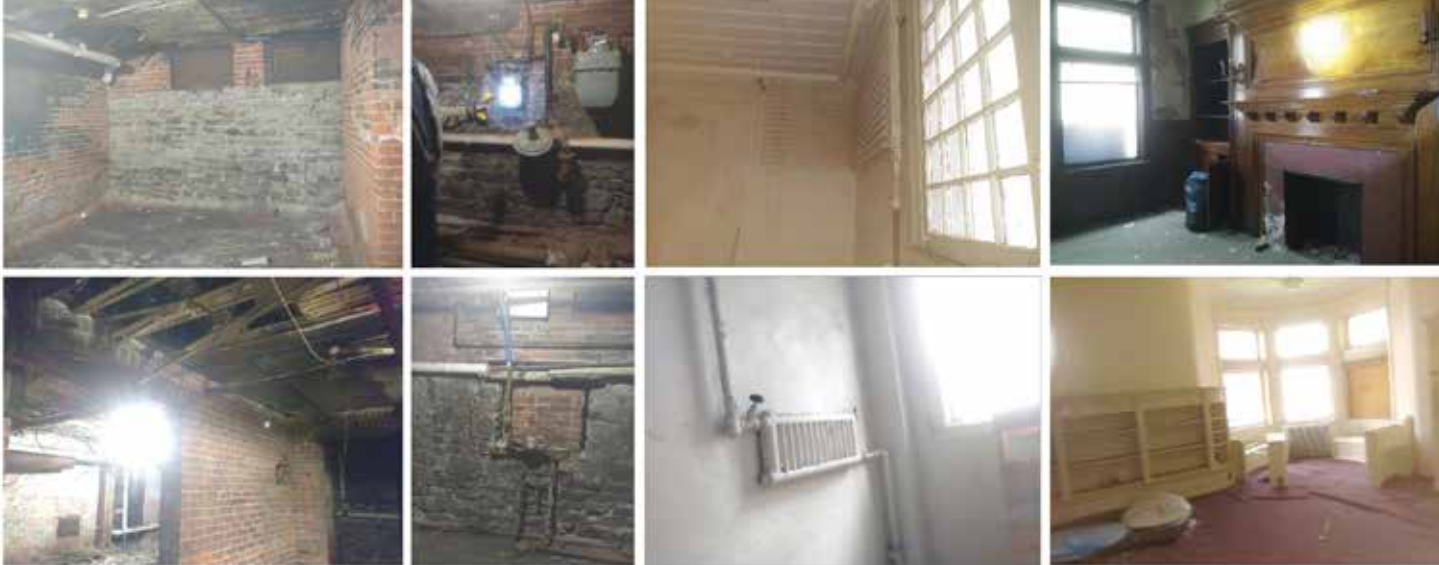
- Need replace heating system related piping and radiators.
- Need to add cooling and ventilation system.
- Possible asbestos.
- Entire electrical infrastructure should be upgraded.

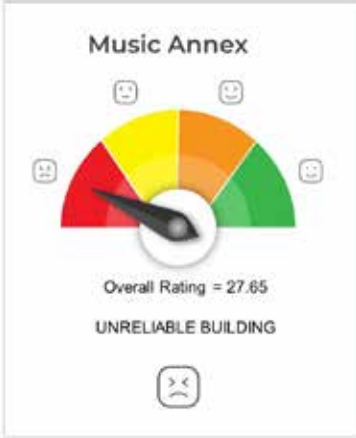
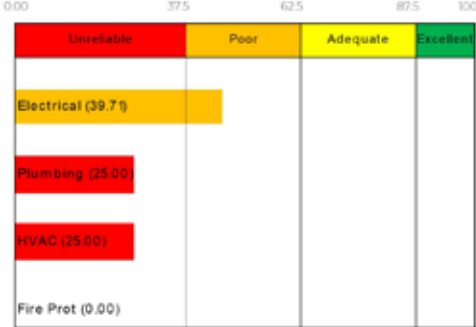
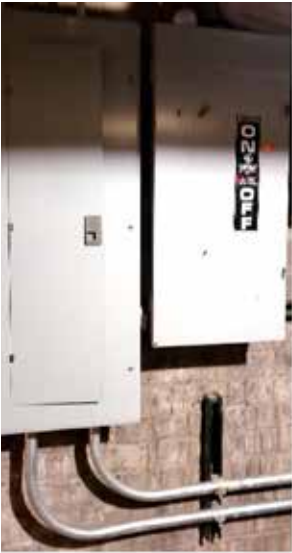
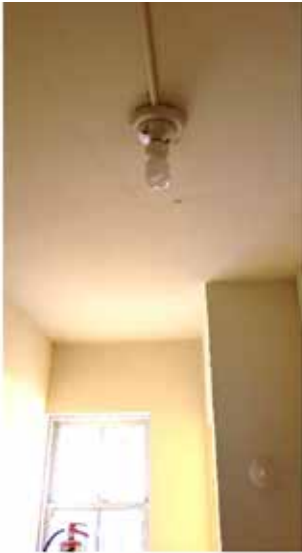
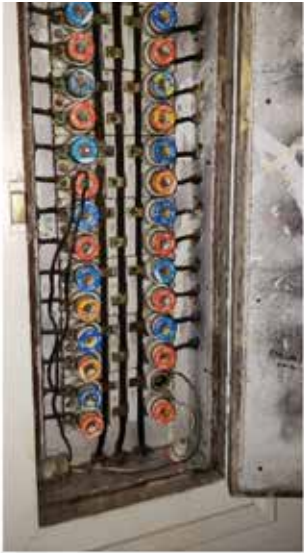
- Domestic water piping needs to be replaced.
- Steam piping and radiators need to be replaced.
- No cooling system
- No fire protection system
- Entire electrical infrastructure should be upgraded.

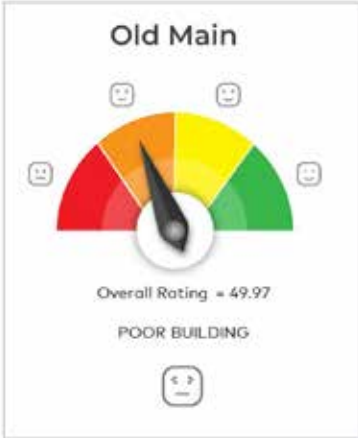
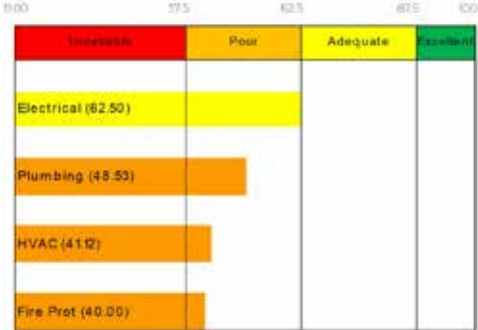
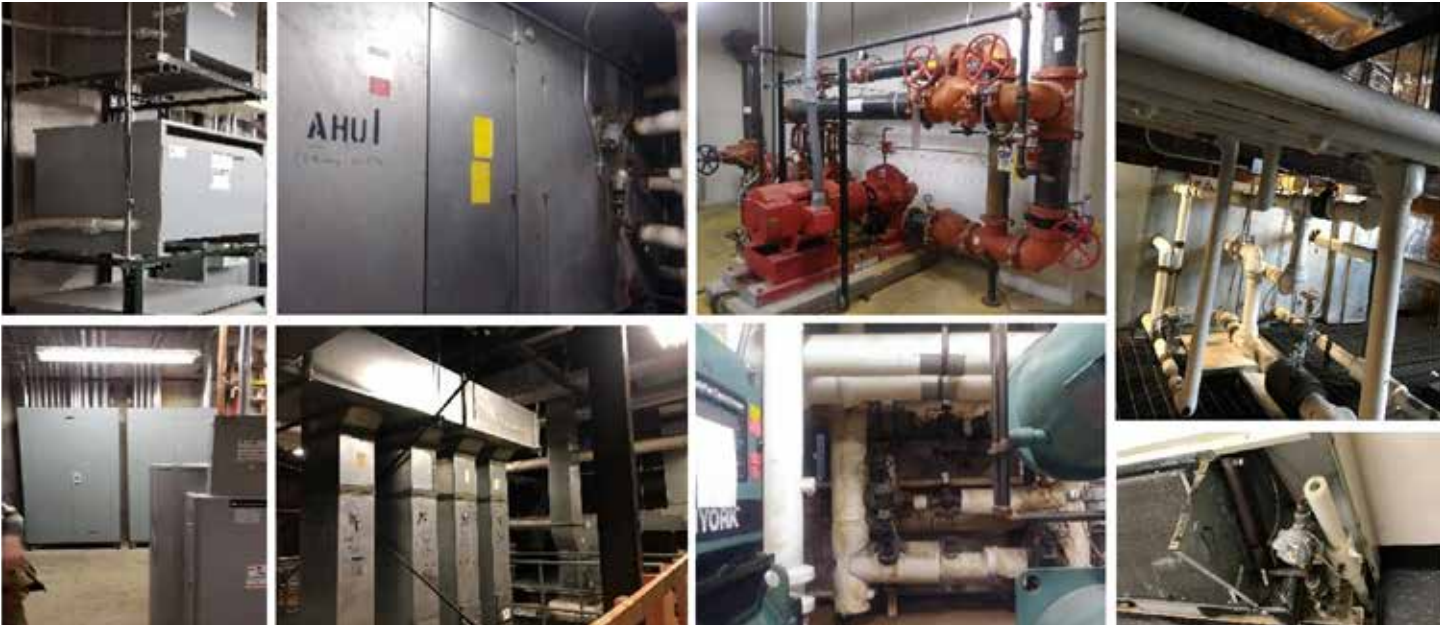
- Emergency lighting is insufficient
- Electrical distribution panels are at least 25 years old
- HVAC is old and inefficient.
- Many roof leaks
- Some fire protection sprinkler heads are over 50 years old and need replacement

- Some fire protection sprinkler heads are more than 50 years old, passed their service time, need to be replaced.
- (3) Chiller installed in 1995, they are around the end of their service life time, (2) w/R22, 350 ton each, and (1) absorption chillers at 400 ton. Refrigerant monitoring not working.

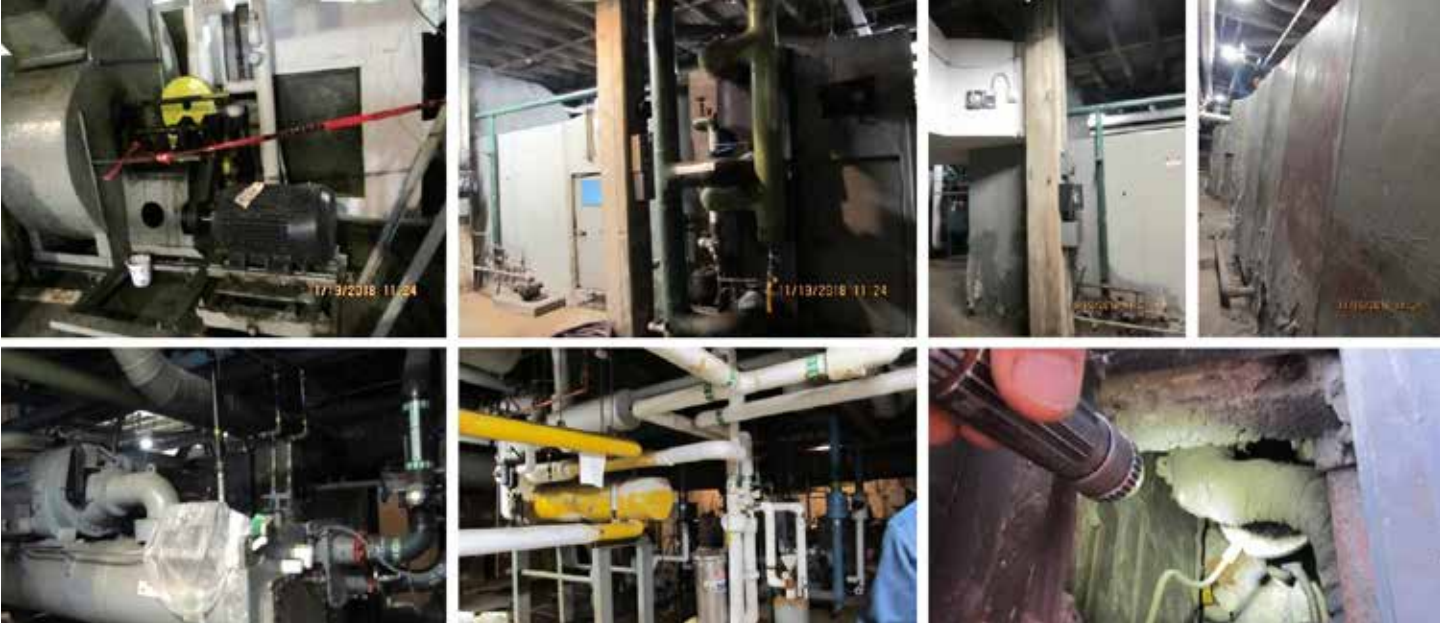
# PURDY LIBRARY

Key takeaway: The mechanical systems at Purdy Library cannot support library stacks and office operations without significant investment.

- Aging incoming power and power distribution with panelboards with little spare capacity.
- There is no automatic means of lighting control in the building, which does not meeting current energy codes.
- Refrigerant monitoring is not working. There is a leak in one of cooling tower's basin (plan is to replace soon).
- Induction AHUs provide heating & cooling for perimeter rooms are original to the building. There is no control on room temperatures.
- Fan coil units serving rooms are not working due to corroded valves and scales.
- Leakage from roof storm piping (or possibly domestic cold water piping) above lighting.
- Old pneumatic controls, and manual controls, need to be upgraded.

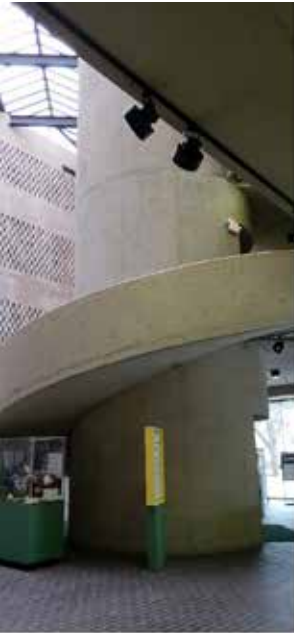
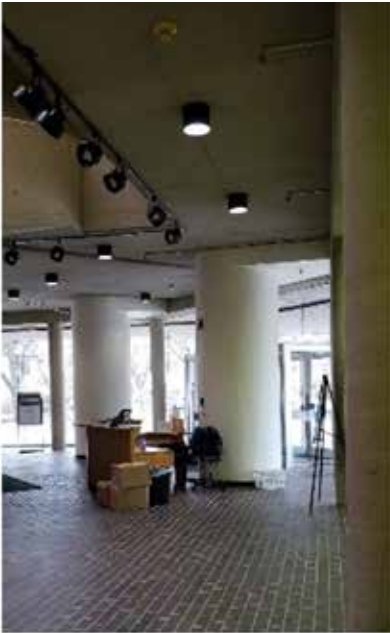
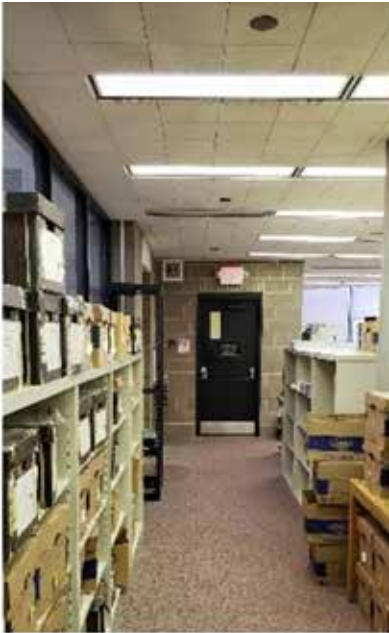
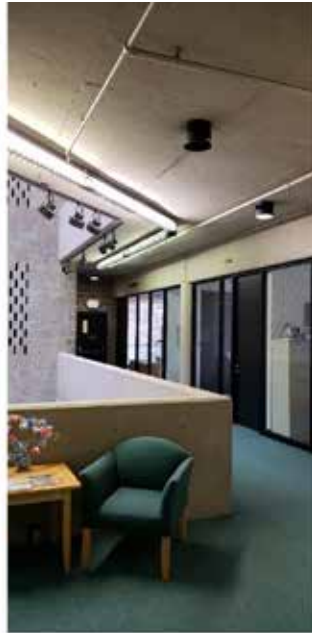
- There are no controls on temperature and humidity for critical spaces.
- Outdated lighting with dim lighting levels.

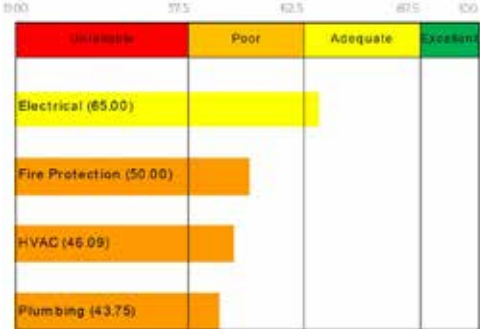
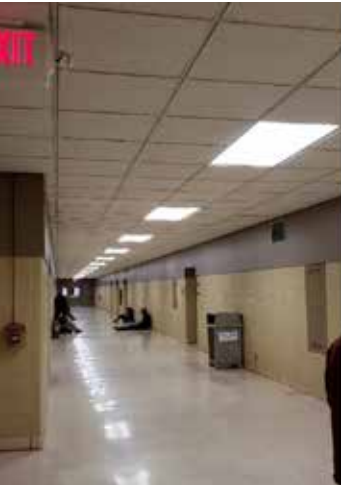
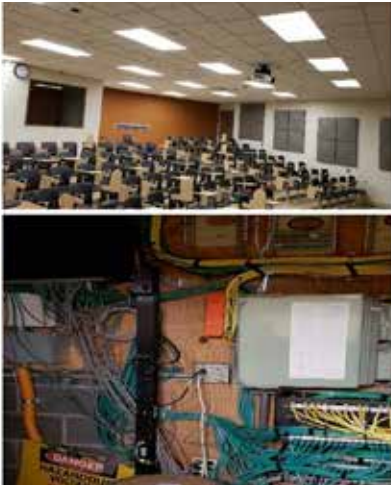
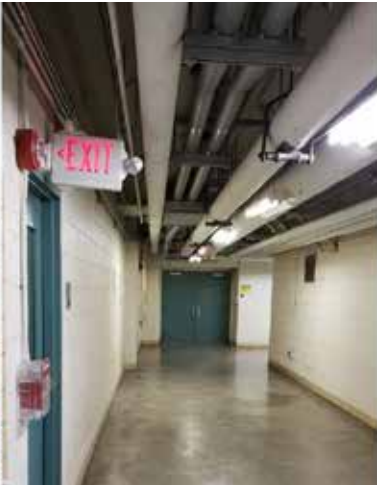
- The incoming power for this facility is original and operated by Public Lighting and is 4800V. It was observed that this building will be upgraded to a 13.2KV service by DTE within 3 years.
- Corridor mounted panel boards have little spare capacity and are original to the building.

- There are many leaks from roof. No over flow roof drain. New roofing will provide better seal and insulation that will save energy. Code requires installing new overflow roof drain system when replacing roof.

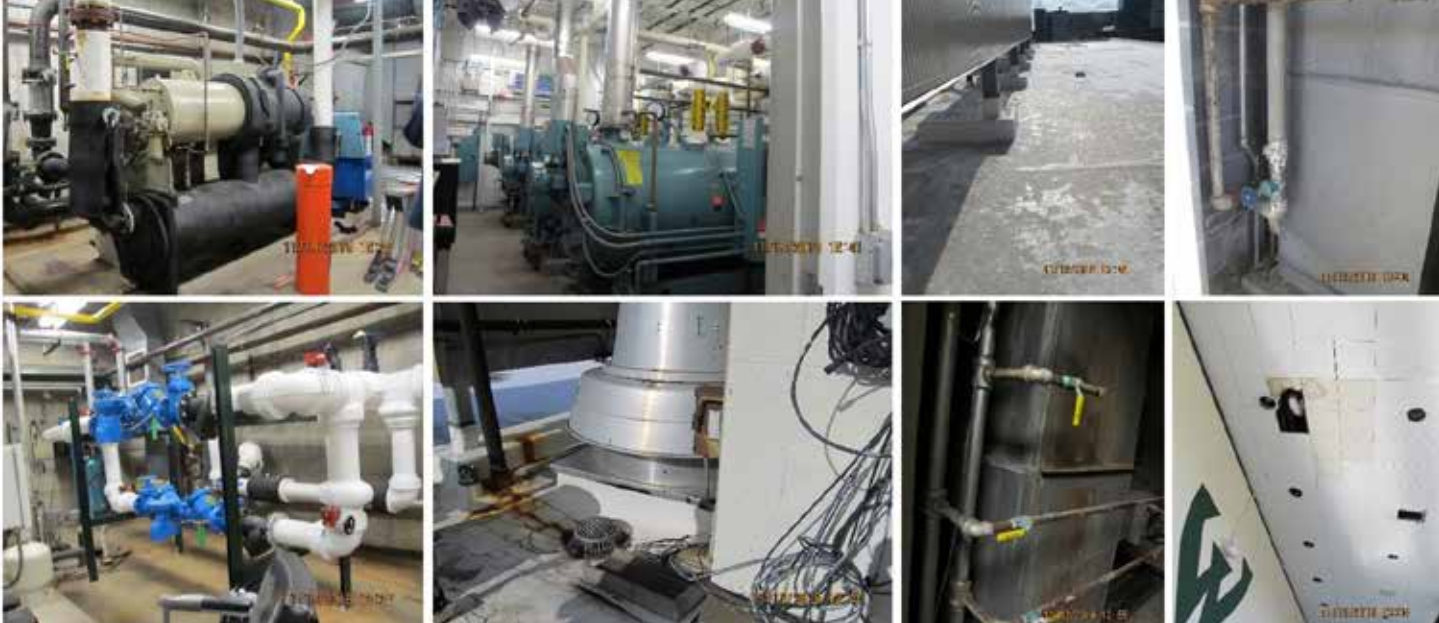
# SHAPERO HALL

Key takeaway: The mechanical systems at Shapero Hall cannot support teaching lab activity without significant investment.

- New transformer and switchgear.
- There is no automatic means of lighting controls in the building which does not meet current energy codes.
- Single chillers, cooling tower, air handling unit, supply fan, and return fan. No back-ups for equipment failure.
- Three heating hot water boilers installed in 2007 are in good working condition.
- No fire protection sprinkler system in the building.
- New fire protection sprinkler system needs to be evaluated (possible grandfather option).
- Need to upgrade the fire alarm and lighting system and lighting controls in this building

- There is no FP for building except 4th floor. Fire pump, stand pipes were added to serve 4th floor when built. Adding new fire protection sprinkler system need to be evaluated, and if possible to grandfather the building, in this case might waive the need for new sprinkler system.

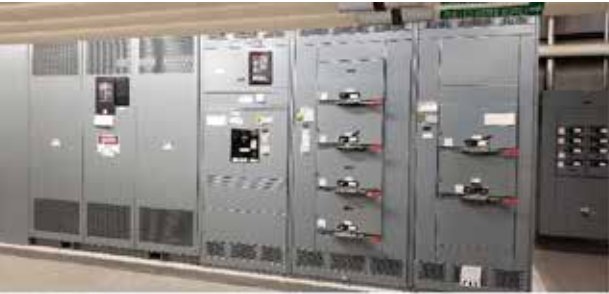
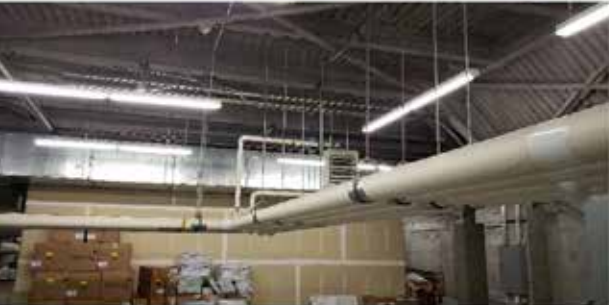
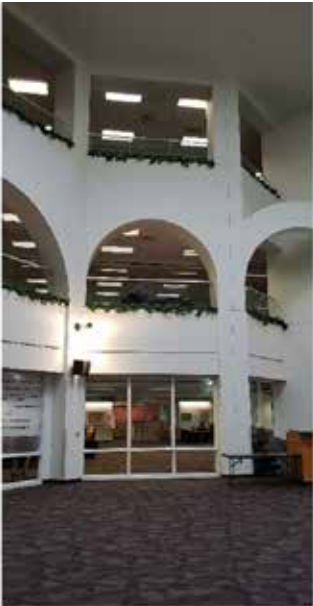
# UNDERGRADUATE LIBRARY

Key takeaway: The systems at the Undergraduate Library are in overall adequate to excellent condition.

- Dock area storm piping leak to be addressed in spring 2019.
- Large cold area at open entrance area on all four floors. Students were wearing their winter coats.
- Heating and cooling needs to be evaluated for additional requirements.
- There are no major electrical concerns, however there is no automatic means of lighting control in the building which does not meet current energy codes.
