**THE WAYNE FRAMEWORK 2019** APPENDIX

# SUMMARY OF BUILDING ASSESSMENT

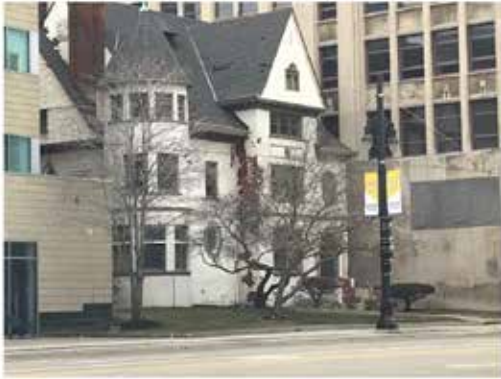
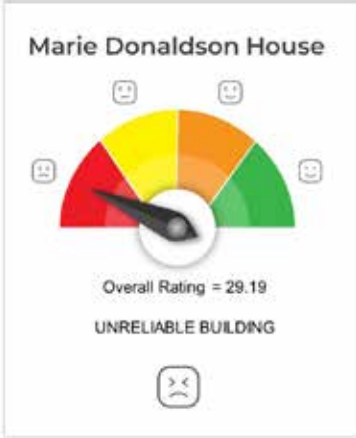
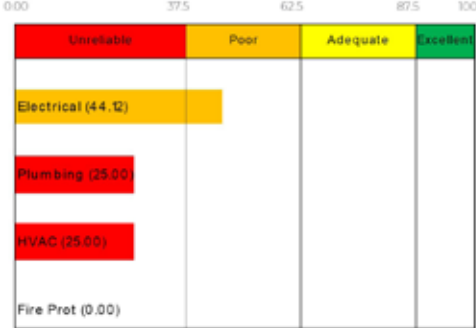
# MARIE DONALDSON HOUSE

Key takeaway: The systems at Marie Donaldson House cannot support office operations without significant investment.

- Need replace heating system related piping and radiators.
- Need to add cooling and ventilation system.
- Possible asbestos.
- Entire electrical infrastructure should be upgraded.

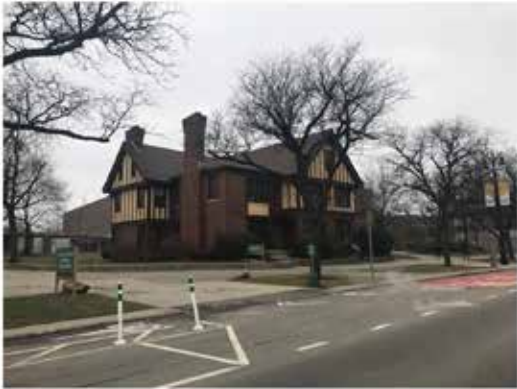
# MUSIC ANNEX

**Key takeaway: The systems at Music Annex cannot support office operations without significant investment.**

- Domestic water piping needs to be replaced.
- Steam piping and radiators need to be replaced.
- No cooling system
- No fire protection system
- Entire electrical infrastructure should be upgraded.

- Steam heat, no cooling, may have used window air conditioners.
- Steam not getting to radiators above the basement level, piping could be plugged. The PRV in the basement is acting as control valve. Steam piping has patches in it. Should be replaced.
- Building water piping is a combination of copper and black iron. Should be replaced

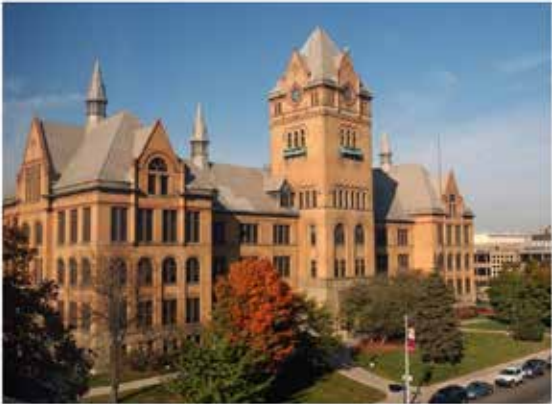
# OLD MAIN

Key takeaway: The mechanical systems in Old Main can not support office, lab and classroom activity without significant investment.

- Emergency lighting is insufficient
- Electrical distribution panels are at least 25 years old
- HVAC is old and inefficient.
- Many roof leaks
- Some fire protection sprinkler heads are over 50 years old and need replacement

- There are many leaks from roof. No over flow roof drain. New roofing will provide better seal and insulation that will save energy. Code require to installing new overflow roof drain system when replacing roof.

- Some fire protection sprinkler heads are more than 50 years old, passed their service time, need to be replaced.
- (3) Chiller installed in 1995, they are around the end of their service life time, (2) w/R22, 350 ton each, and (1) absorption chillers at 400 ton. Refrigerant monitoring not working.

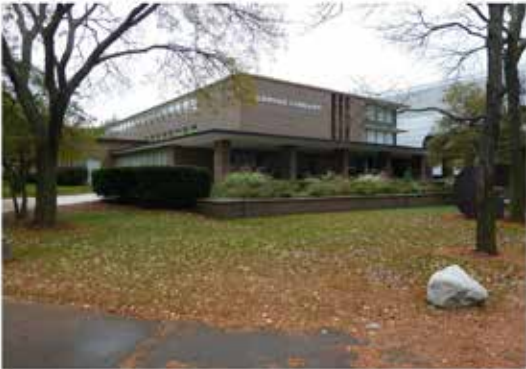
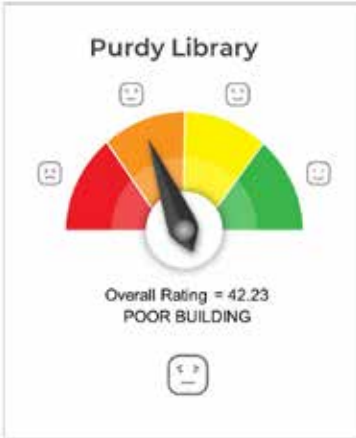
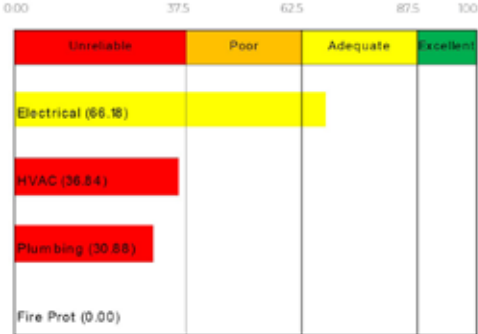
# PURDY LIBRARY

Key takeaway: The mechanical systems at Purdy Library cannot support library stacks and office operations without significant investment.

- Aging incoming power and power distribution with panelboards with little spare capacity.
- There is no automatic means of lighting control in the building, which does not meeting current energy codes.
- Refrigerant monitoring is not working. There is a leak in one of cooling tower's basin (plan is to replace soon).
- Induction AHUs provide heating & cooling for perimeter rooms are original to the building. There is no control on room temperatures.
- Fan coil units serving rooms are not working due to corroded valves and scales.
- Leakage from roof storm piping (or possibly domestic cold water piping) above lighting.
- Old pneumatic controls, and manual controls, need to be upgraded.

- (4) Chillers serving Purdy, Kresgy and part of other buildings, (1) 180 ton. (2) 250 ton, installed in 1996-1999, there should be more years to serve. Refrigerant monitoring not working. (4) Cooling towers, installed 1996-1999. There is leak in one of cooling tower's basin, the plan to replace soon.

- Induction AHUs provide heating & cooling for perimeter rooms, they original to the building. There is no control for rooms' temps.
- Fan coil units serving rooms, not working fine; corroded valves with scales.

- Boilers installed in 2008, working fine, still many years remaining in their expected service life time.
- Building manger asked us to report the leakage from roof storm piping (or it might be from DCW piping) to the ceiling, the concern this leak is over lighting.

- There are many leaks from roof. No over flow roof drain. New roofing will provide better seal and insulation that will save energy. Code requires installing new overflow roof drain system when replacing roof.

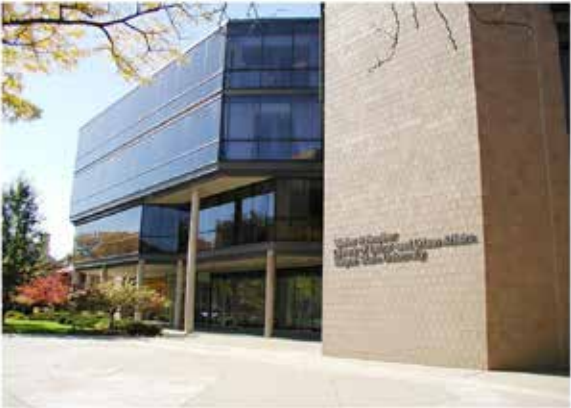
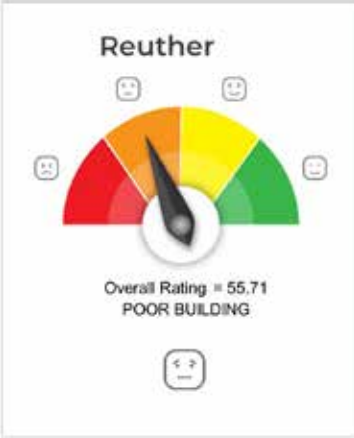
# REUTHER LIBRARY

**Key takeaway:** The mechanical systems at the Reuther Library cannot support library stacks and office operations without significant investment.

- There are no controls on temperature and humidity for critical spaces.
- Outdated lighting with dim lighting levels.

- Unable to access the incoming power room
- Exit signage spacing does not meet current codes
- Lighting is outdated and has very dim lighting levels.
- No automatic means of lighting control in the building which does not meet current energy codes.
- No temperature or humidity controls currently installed for spaces with old collections of photographs, microfilms, glass plate negatives, film negatives and storage spaces.
- RTUs and AHUs provide supply air to each zone by VAV-boxes, they are original to the building, and we are told there is asbestos insulation.
- Need to check if the back flow preventer installed on the main FP line is per code.
- Domestic water heater provided by water heater, no issue reported.
- Study was performed in recent years for HVAC systems improvements, but no recommendations were implemented.

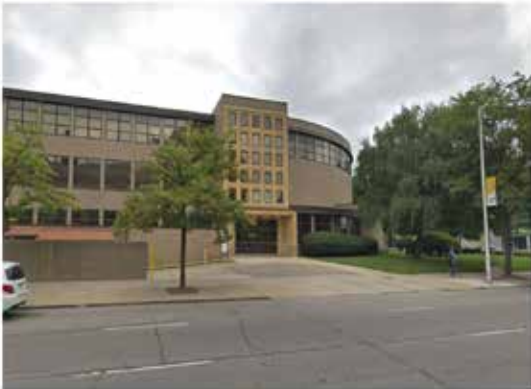
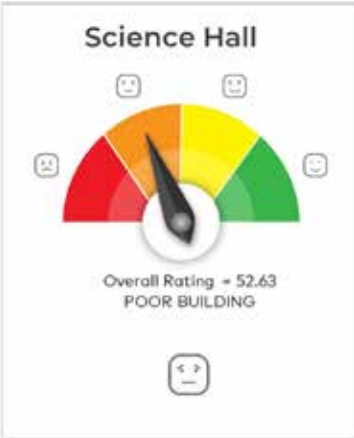
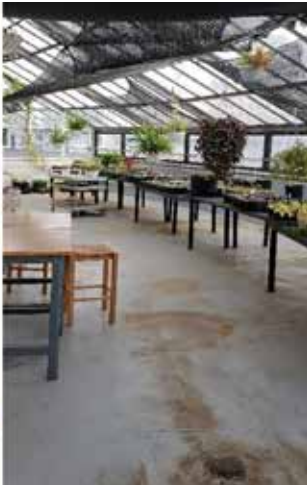
# SCIENCE HALL

**Key takeaway:** The mechanical systems at Science Hall cannot support teaching labs and classroom activity without significant investment.

- The incoming power for this facility is original and operated by Public Lighting and is 4800V. It was observed that this building will be upgraded to a 13.2KV service by DTE within 3 years.
- Corridor mounted panel boards have little spare capacity and are original to the building.

- Needs new hot water source.
- Domestic water piping should be replaced.
- Labs need new lab air compressor.
- Not all lab hoods have controls.
- Lab vacuum system does not function and needs replacement.
- Siemens controls on food and nutrition lab hoods only.
- Steam to booster coils no hydronic water.
- Steam condensate needs to be replaced.
- No fire pumps.
- City water pressure for sprinklers in storage areas.
- Building needs a major electrical distribution upgrade.
- Incoming service is 4800V provided by Public Lighting.
- The entire building is backed up by a 500KW generator

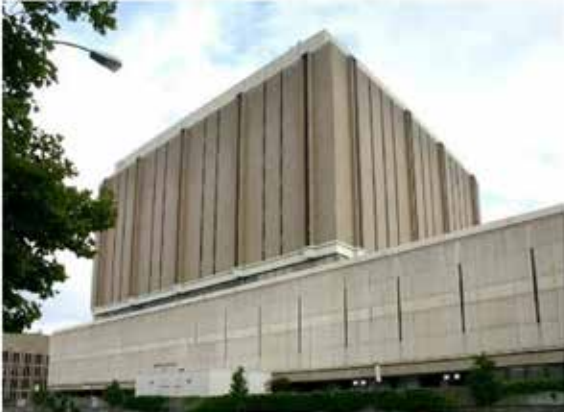
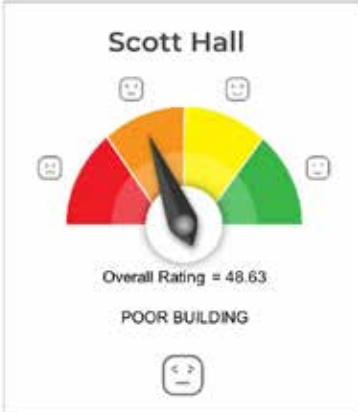
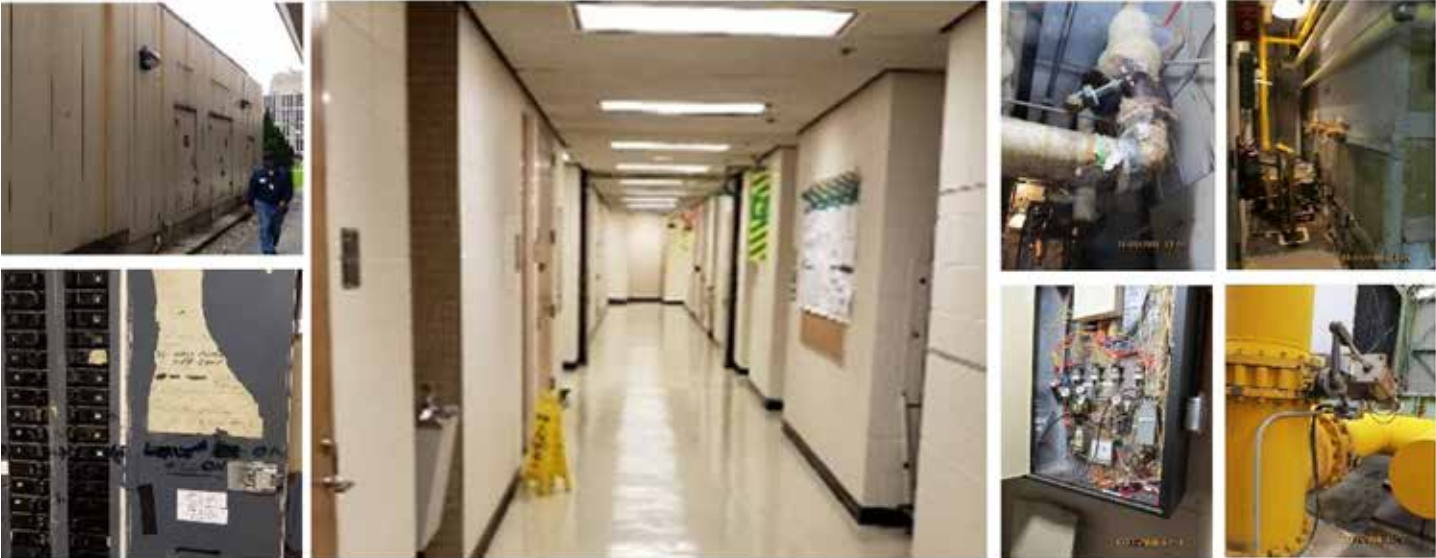
# SCOTT HALL

Key takeaway: The mechanical systems in Scott Hall can not support intensive research activity without significant investment.

- Lighting and means of controls are not energy efficient and should be upgraded to current energy code
- Exit signage and emergency lighting are not code compliant with current life safety standards
- Most HVAC systems are original to the building and are beyond equipment life expectancy

- The panelboards are in good condition with limited spare capacity in the majority of them.
- The entire building has emergency power supplied by two (2) diesel generators, (generator sizing was not possible at the time of the visit). There is a UPS system that is providing power to multiple labs, this is distributed thru various 208/120V panelboards.

- There are fixtures with missing or burned out lamps, and fixtures that have lamps with color temperatures that do not match the rest.
- There are a few area that have occupancy sensors, for the majority of the building there are no lighting controls.

- Most HVAC systems are original to the building very old inefficient; double deck supply ductwork, rusty burst leaking coils, dampers, piping, valves, some replaced, but still many needs replacement. Some asbestos insulation.

- Controls need to be upgraded, most control pneumatic very old.
- Chillers and cooling towers are around their end of service life time. It is very hard to control cooling tower water flow as the 3-way valve on main pipe not working.

- There are many leaks from roof. No over flow roof drain. New roofing will provide better seal and insulation that will save energy. Code requires installing new overflow roof drain system when replacing roof.

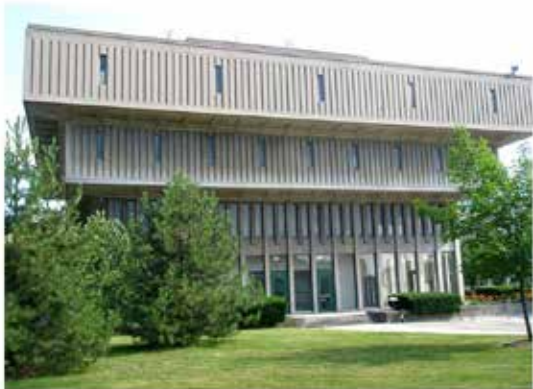
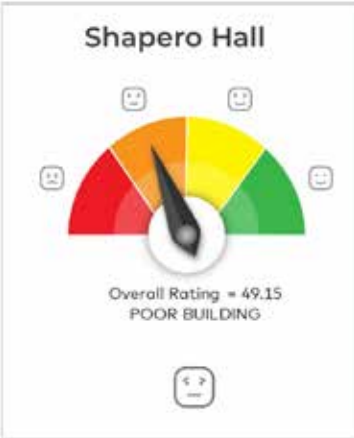
# SHAPERO HALL

Key takeaway: The mechanical systems at Shapero Hall cannot support teaching lab activity without significant investment.

- New transformer and switchgear.
- There is no automatic means of lighting controls in the building which does not meet current energy codes.
- Single chillers, cooling tower, air handling unit, supply fan, and return fan. No back-ups for equipment failure.
- Three heating hot water boilers installed in 2007 are in good working condition.
- No fire protection sprinkler system in the building.
- New fire protection sprinkler system needs to be evaluated (possible grandfather option).
- Need to upgrade the fire alarm and lighting system and lighting controls in this building

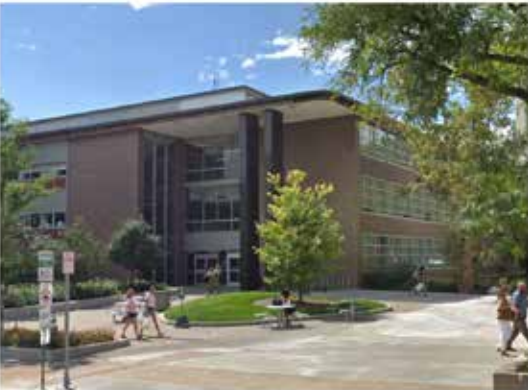
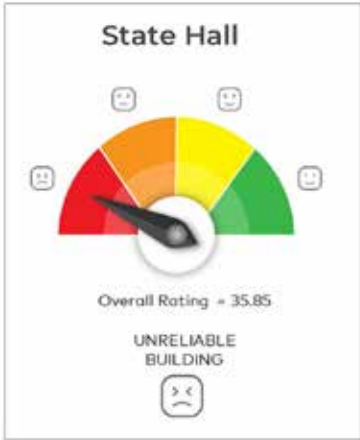
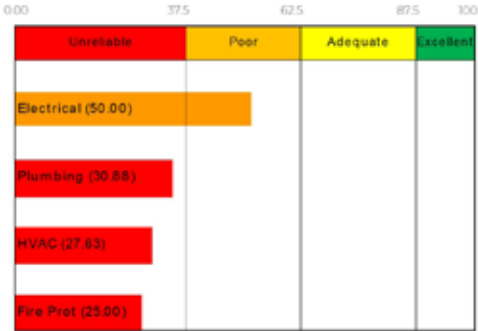
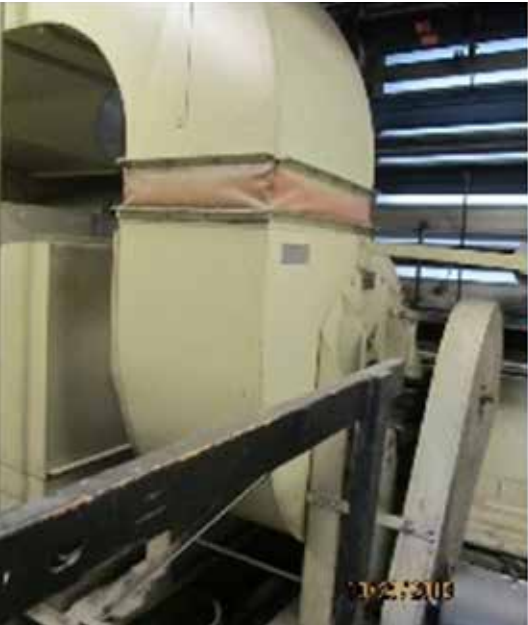
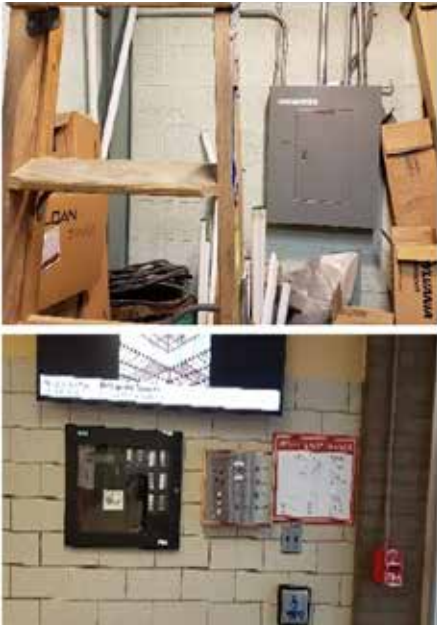
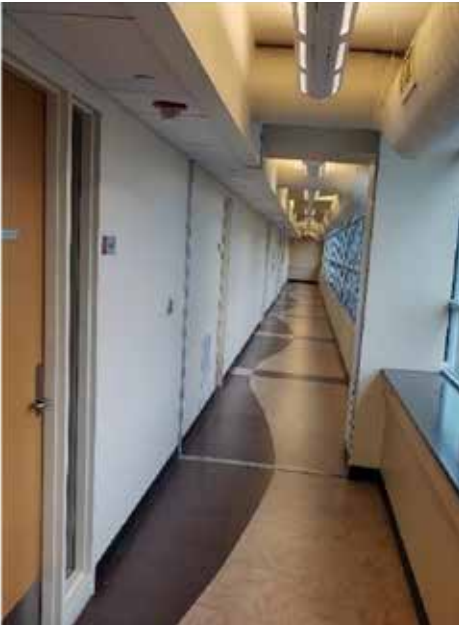
# STATE HALL

Key takeaway: The systems in State Hall can not support classroom activity without significant investment.

- Outdated electrical and mechanical system
- Major overhaul required
- Currently lacking fire protection on all floors, except 4th floor

- Most HVAC systems serving 1st to 3rd floor need to be replaced, they are original to the building 1946-1956 very old inefficient system; rusty burst leaking coils, dampers, piping, valves, some replaced, but still many needs to be replaced. Return Air [RA] routed thru underground tunnel where steam piping routed, RA temp raised thru this tunnel as some of piping not insulated or insulated with asbestos.

- Also there is asbestos insulation.
- Control is pneumatic, very old rusty valves and actuators, need to be upgraded.
- Domestic cold water piping are original to the building contain lead need to be replaced.

- There are many leaks from roof. No over flow roof drain. New roofing will provide better seal and insulation that will save energy. Code require to install new overflow roof drain system when replacing roof.

- There is no FP for building except 4th floor. Fire pump, stand pipes were added to serve 4th floor when built. Adding new fire protection sprinkler system need to be evaluated, and if possible to grandfather the building, in this case might waive the need for new sprinkler system.

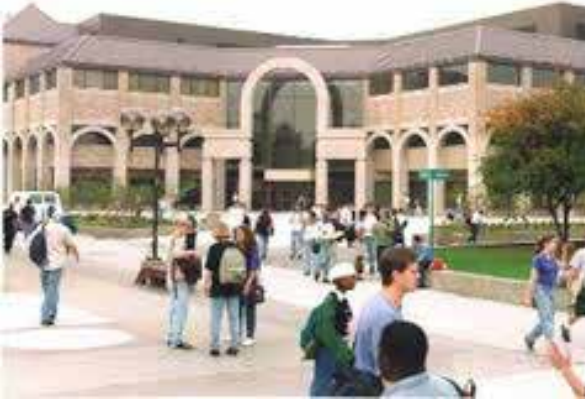
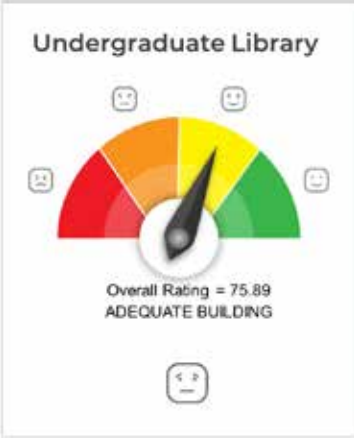
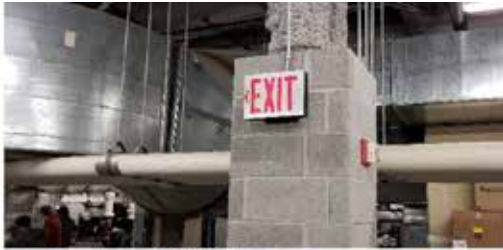
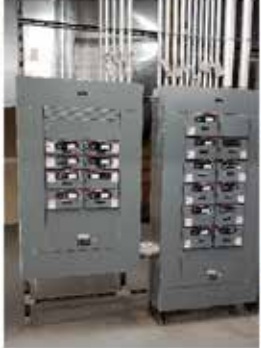
# UNDERGRADUATE LIBRARY

Key takeaway: The systems at the Undergraduate Library are in overall adequate to excellent condition.

- Dock area storm piping leak to be addressed in spring 2019.
- Large cold area at open entrance area on all four floors. Students were wearing their winter coats.
- Heating and cooling needs to be evaluated for additional requirements.
- There are no major electrical concerns, however there is no automatic means of lighting control in the building which does not meet current energy codes.

- The incoming power is (2) 4800V lines incoming into a medium voltage switchgear for 480V distribution. Although this is not a 13.2KV service, it is understood that there is a redundant line and service has been reliable.
- Heating hot water pumps were replaced. Operators are very happy with new pumps.
- DDC Controls.
